DEPARTMENT OF HEALTH

NORTHWEST DRINKING WATER REGIONAL OPERATIONS

Livingston Bay Community Association President John Gablehouse 26910 92 nd Ave NW C-5 Pmb 412 Stanwood WA 98292	Livingston Bay Community ID #47628	
	County:	Island
	System Type:	A-Comm
	Operating Permit Color:	Green
	Surveyor:	Laura McLaughlin
	Inspection Date:	December 10, 2019

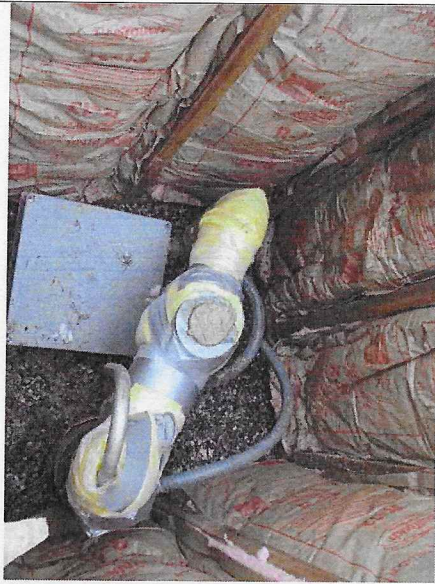
The well is located in a dog house next to the treatment building. The insulation has been replaced since the last survey, a good temporary fix. Consider replacing the enclosure and ensure it is isolated from the outside.

S01, well 1, Improved insulation

- The loose insulation at the wellhead attracts rodents. **You should replace the enclosure with a type that is well isolated from the outside and only use rigid foam board insulation or cover the wool with boards.** 2019 UPDATE: COMPLETE: reinsulated dog house.

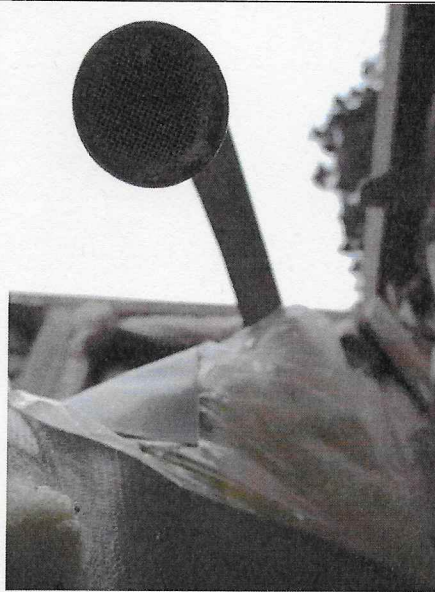
Screened well vent

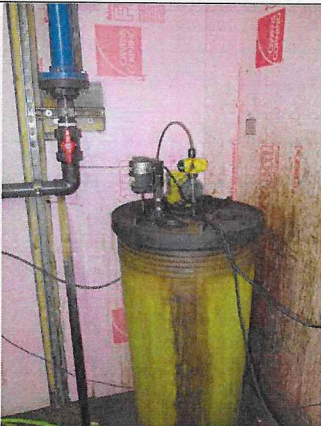
KMnO4 feed tank and injection pump

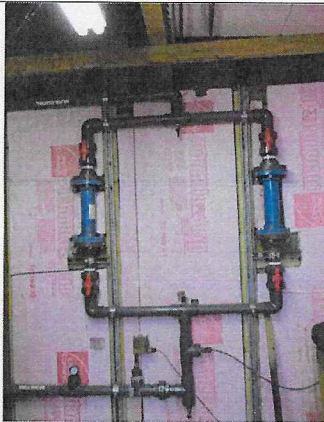
KMnO4 injection point, followed by 2 static mixers

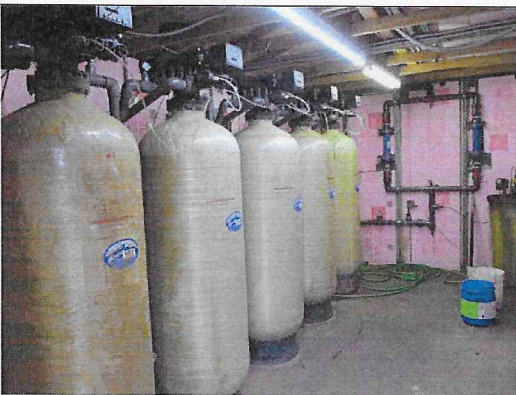
5. We discussed some technical issues with the Fe/Mn treatment. Two of the five Greensand filters were not functioning during the survey, and one control valve was not functioning during the last survey as well. I understand that the system eventually plans to upgrade the treatment system. With two of the filters offline, the treatment may not be working as expected. Pre and post treatment iron and manganese monthly sample results were not available at the time of the survey to assess whether the treatment is working as expected. I recommend **reviewing iron and manganese data collection plan and reviewing data to find out if treatment is working**. **Please contact Denis Mehinagic, the regional engineer for Island County, regarding any changes to treatment**. Note that the system must submit a project report for changes or upgrades to the system.

The well water is high in manganese. The treatment is designed to remove it through oxidation and filtration. Potassium permanganate is used for oxidation and greensand for filtration. This treatment dates back to 1998 and may be nearing the end of its design life. Two of the five filters were not functioning during the survey, and the main control valve was not working during the last survey. During the past two surveys the filters were

5 Greensand filters, 2 were off-line.

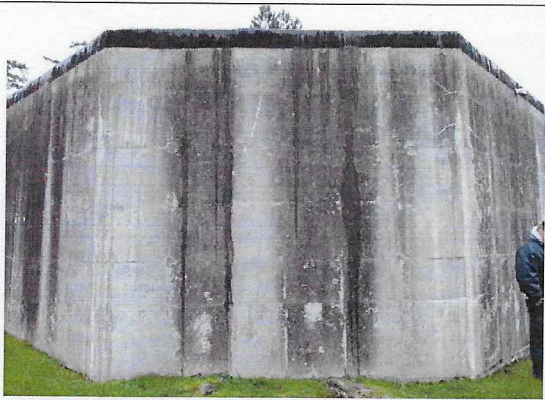
First, I’d like to acknowledge the system’s recent work to address the tank leakage with a liner. The operator says the liner is working as expected and leaks have decreased substantially. Great work!

RESERVOIR	DESCRIPTION	TOTAL VOLUME (GAL)
1	60,000 gallon above ground octagonal concrete tank; several corners were leaking and the top has a crack. A new liner was installed in the tank since the last survey.	60,000

Octagonal, newly lined tank

- c. Emergency response
4. While the liner and sealant repair to the crack in the tank roof seem to have improved the performance of the tank, liners and sealants run a risk of leaking/failing. Now that the tank seems to be working properly, it's a good time to **plan and budget for tank replacement**. Also, **examine the tank for structural stability and develop an inspection schedule to routinely inspect for tank and roof** for new cracks or leaks.

- Consider installing a liner or a new reservoir is needed for your community. 2019 UPDATE: COMPLETE/ONGOING, INSTALLED LINER. NEED TO PLAN FOR REPLACEMENT.

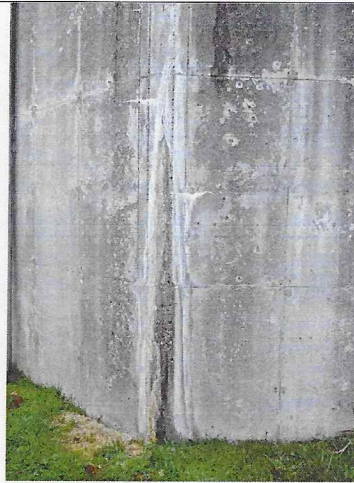
Tank corner with cracks

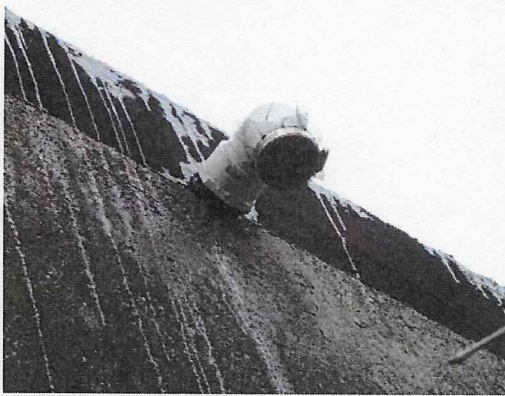
Screened tank overflow

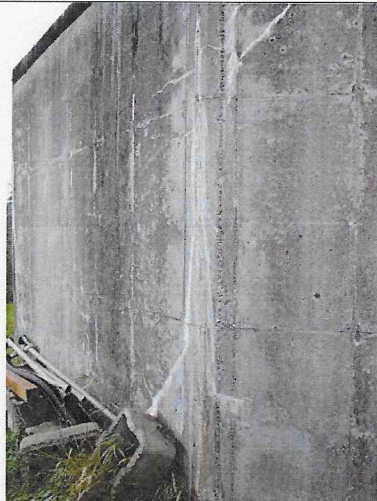
Tank wall with cracks

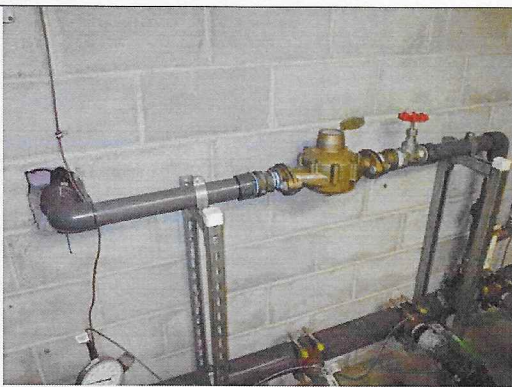
Source meter? (in pump house)

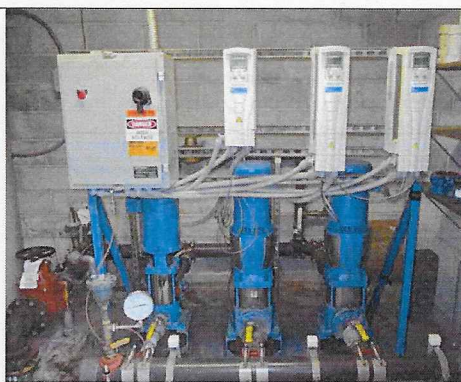
Facility	Name	Description	Total Capacity (gpm)
1		The booster pump station is a constant pressure variable-frequency drive consisting of one 5HP and two 7.5 HP. The 5hp is in lead all the time. The larger pumps come on only if the smaller pump cannot keep up with the demand	Unknown

Booster pump station and VFDs.

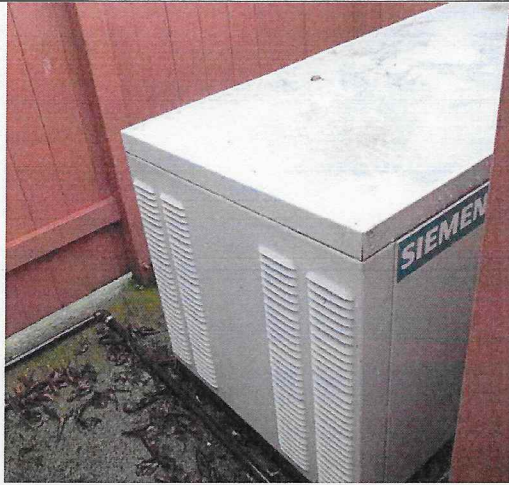
Backup generator
